## Behavior Of Low-Cost Cci Brick Prisms Subjected To Axial Cyclic Compression And Lateral Forces

This study focuses on CCI brick walls, which use minimal mortar and are designed to withstand axial and lateral forces. It investigates how CCI brick prisms respond to cyclic axial loading and explores their bond strength for withstanding lateral loads. The study accounts for regional soil variations in Thailand by using bricks from different areas. The results show consistent behavior in cyclic loading and an increasing load capacity until failure. Reinforced specimens with steel bars outperform those with grout only and the unaltered specimens. Combining cement-sand grout and steel bar reinforcement leads to significant improvements in compressive strength, particularly in smaller and larger height specimens. Non-shrink Cement Sand Grouts exhibit superior bond strength over Ordinary Portland Cement Sand Grouts, and CCI bricks from region 2, known for their higher compressive strength and larger grooves, demonstrate the highest bond strength. The findings emphasize the importance of groove depth in determining bond strength in CCI brick prisms.

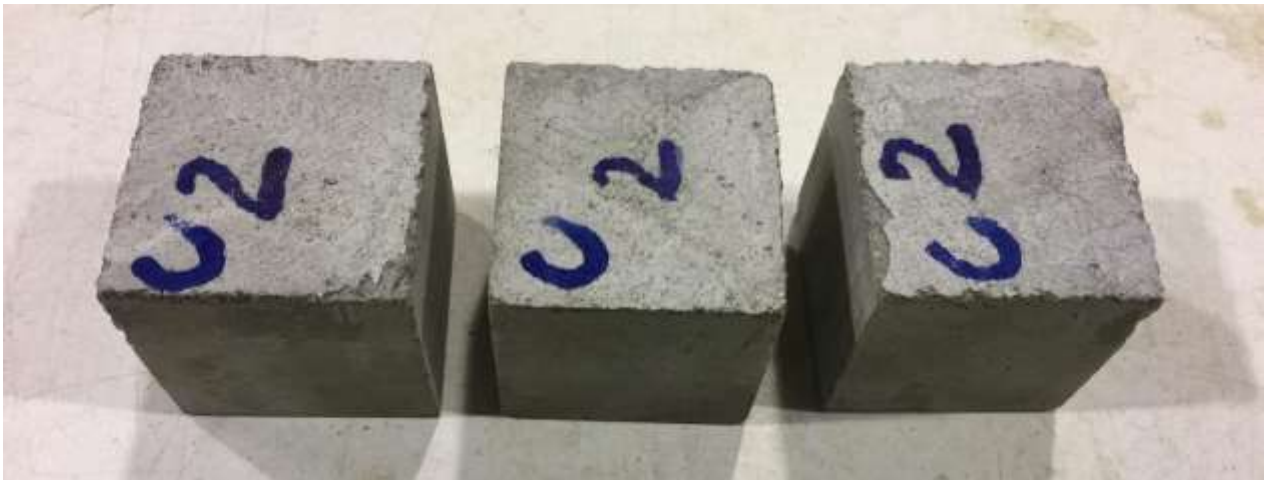
Figure 3. Cubes ready for testing compressive strength of cement-sand grout.

The compressive strength of grouts was estimated by testing standard cubes of 50 mm dimensions, as shown in Figure 3. The compressive strength of cement-sand and non-shrink cement sand grouts was estimated at 25 MPa and 50 MPa, respectively. In some specimens, round steel bars of 6 mm diameter were used in addition to the grouts. The yield and ultimate strength of steel bars were estimated at 340 MPa and 420 MPa, respectively.

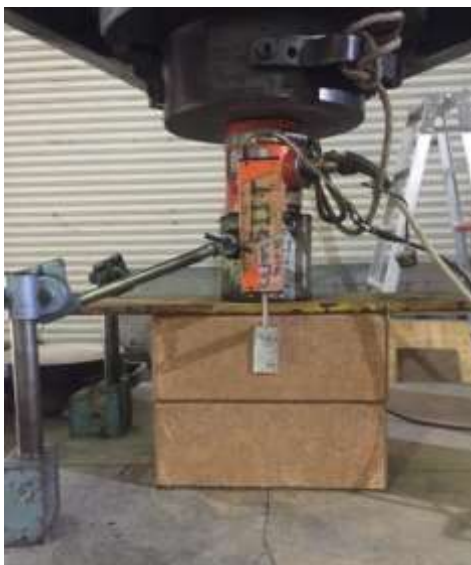
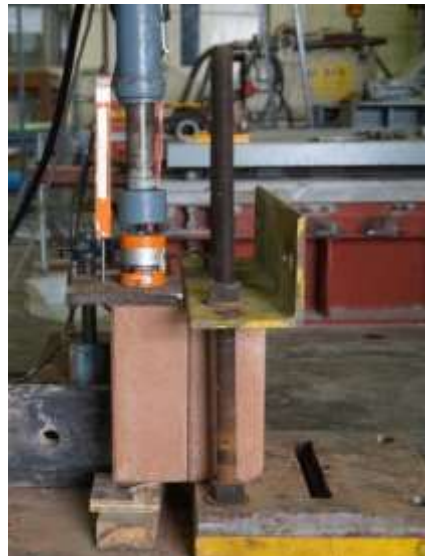
Figure 4. Typical test setup for (a) axial cyclic compression and (b) bond strength

A Universal Testing Machine with a capacity of 500 kN was used to apply axial cyclic load, as shown in Figure 4(a). In this case, the direction of the applied load was perpendicular to the direction of the courses. On the contrary, brick prisms were tested to fail in shear parallel to the direction of the courses, as shown in Figure 4(b).

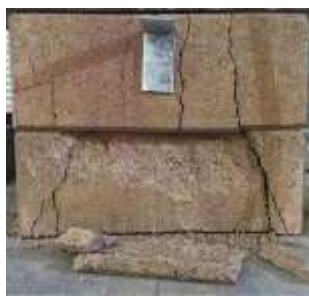
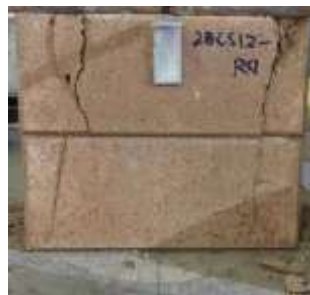
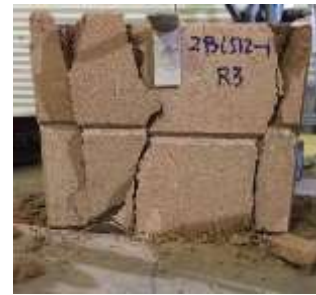
Figure 5. Failure modes of specimens tested under axial cyclic loads.

Figure 5 displays the failure modes for both specimen configurations. It's evident that in both configurations, cracks developed parallel to the prism's plane. This type of failure is commonly observed in clay masonry, consistent with findings from other researchers. Notably, the specimens that were reinforced with grout and reinforcement, specifically 2B-CS12-R2 and 3B-CS12-R2, showed more extensive cracking compared to the unreinforced masonry specimens. It is important to note that only failure modes of small height specimens are shown as the failure of specimens with large height was identical. Figure 6 shows the failure of bond test. It is evident that these specimens failed by shearing off the face along the course direction.
